**VEHICLE CRASH TESTS OF THE
TYPE 80 BRIDGE RAIL**

1. REPORT NO. FHWA/CA/ESC-98/06 Part 3		2. GOVERNMENT ACCESSION NO.		3. RECIPIENT'S CATALOG NO.	
4. TITLE AND SUBTITLE VEHICLE CRASH TESTS OF THE TYPE 80 BRIDGE RAIL				5. REPORT DATE March 1999

16. ABSTRACT An aesthetic, see-through concrete bridge rail, Type 80, was built and tested in accordance with NCHRP Report 350. The Type 80 bridge rail is an 810 mm-tall, reinforced concrete barrier. The rail has 280 mm-high by 1620 mm-long gaps, 230 mm above the bridge deck surface. The barrier tested was 23 m-long and was constructed at the Caltrans Dynamic Test Facility in West Sacramento, California. A total of three crash tests were conducted under Report 350 test Level 4, one with a 820 kg car, one with a 2000 kg pickup truck and one with an 8000 kg single unit van truck. The results of all three tests were within the limits of the Report 350 guidelines. The Type 80 bridge rail is recommended for approval on California highways requiring TL-4 bridge rails.

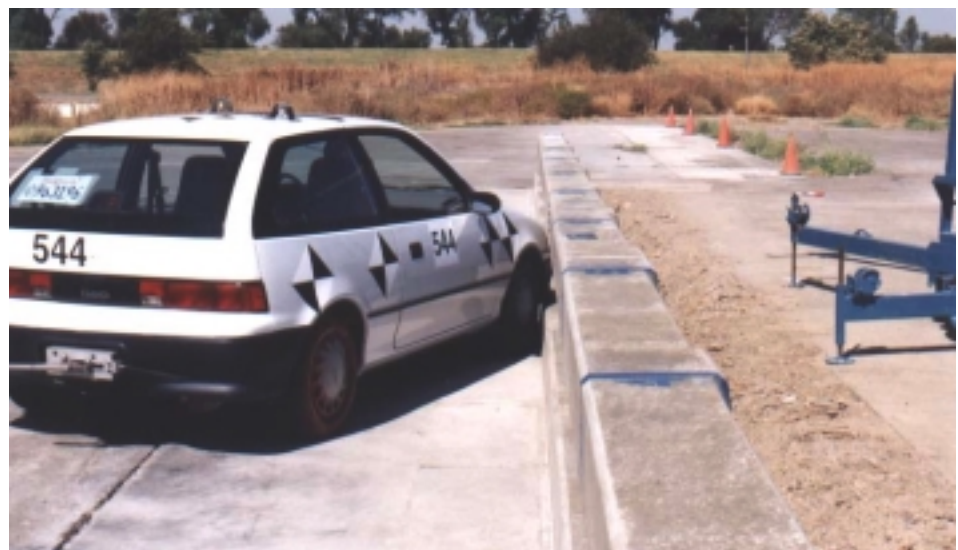
Figure 2-16 Post
Impact Side View of
Vehicle 544

The right front section of the vehicle sustained crushing of the bumper and frame, damage to the suspension and a flat tire, Figure 2-16 through Figure 2-18. The right side of the vehicle from the front bumper to the rear bumper was scraped during contact with the beam section of the rail. The hood was also crushed on the right side but remained attached at the latch and hinges.

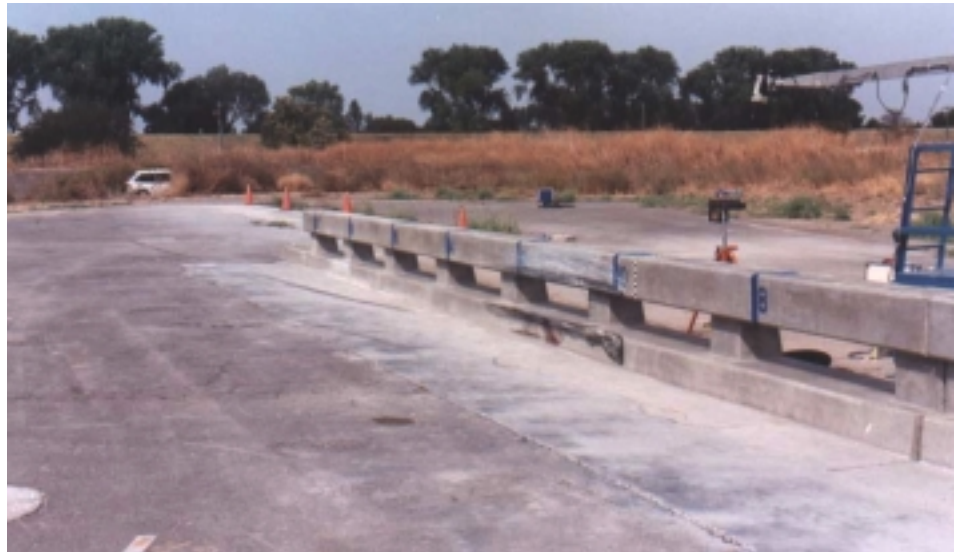
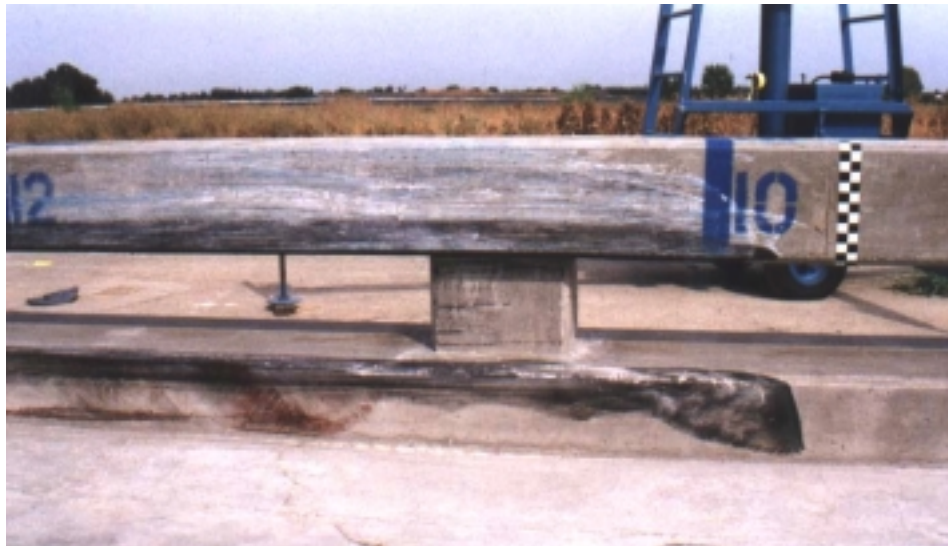
Figure 2-20 Post
Impact Bridge Rail
Scuff Marks Test 544

Figure 2-21 Post
Impact Bridge Rail
Scuff Marks Test
544

Barrier damage was cosmetic only, consisting of scrapes and tire marks. Both of the right side tires left marks on the curb and beam section of the bridge rail. Small amounts of concrete spalled from the face of the barrier where the vehicle’s sheet metal and wheels made contact.

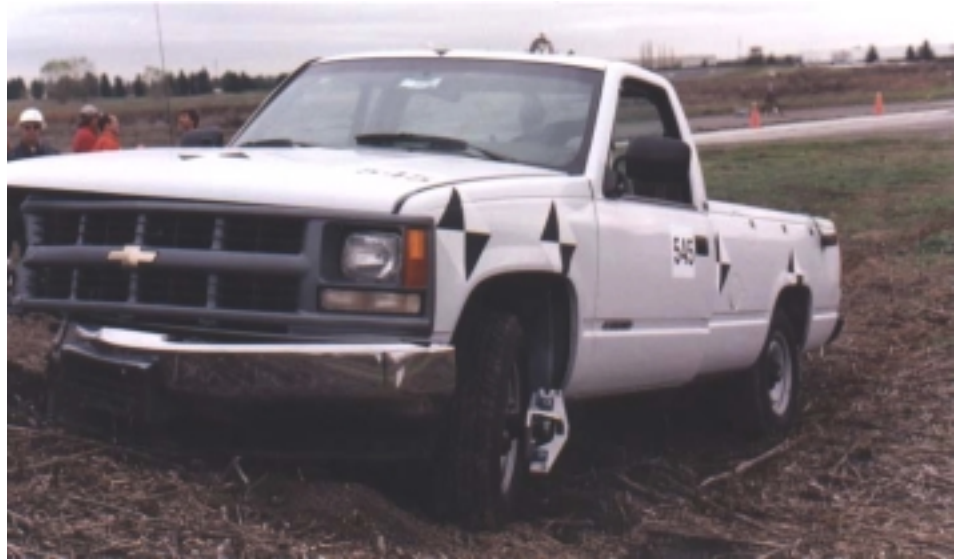
Figure 2-27 Post
Impact Side of Test
Vehicle 545

The vehicle received damage from the right front corner to the right rear corner, Figure 2-27. The right front and right rear wheel rims were deformed and the tires deflated. The left side wheels and tires were undamaged. The spare tire was forced from its undercarriage storage location and ended up about 15 m from the vehicle resting position.

The initial impact occurred on the right front quarter panel, resulting in substantial buckling and scraping, Figure 2-27. The right side of the bumper was pushed back about 260 mm. As the vehicle continued along the rail the entire right side was deformed where it contacted the bridge rail beam face. As a result, the right door did not operate due to moderate buckling and scraping. The truck bed was also scraped and buckled along the right side and the entire bed shifted to the right 40 mm. The tailgate did not function but the hood and left door were left in good condition and were operable. The roof of the truck did not have any signs of buckling. The windshield was cracked but remained mounted. The left and rear windows were not cracked.
